Pavement Rehabilitation Manual

VOLUME 1: PAVEMENT EVALUATION

**MATERIALS BUREAU
NEW YORK STATE DEPARTMENT OF TRANSPORTATION**
Mario M. Cuomo, Governor/Franklin E. White, Commissioner

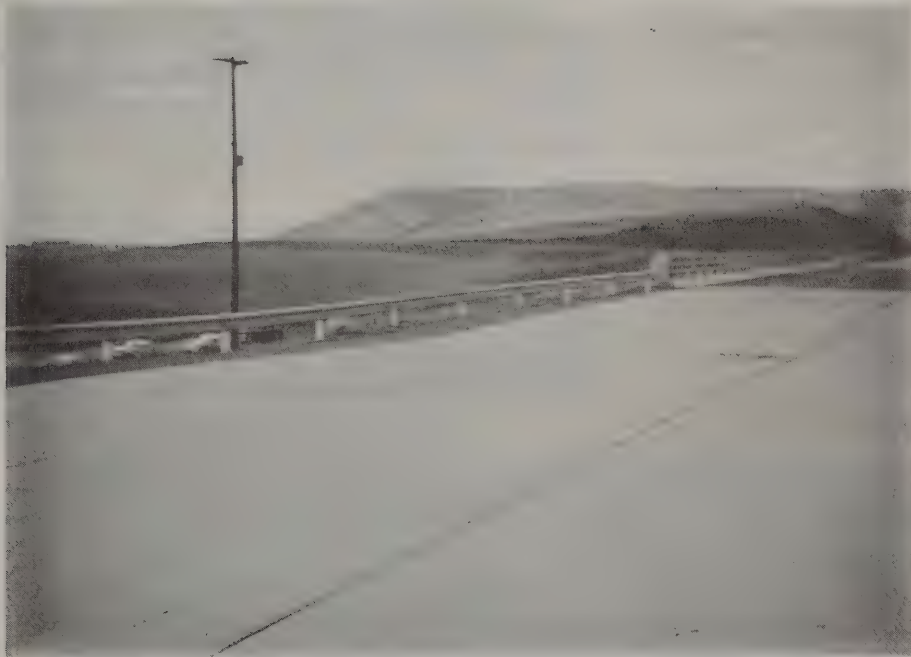
Figure B1 - Settlements and Heaves

Typical Bridge Approach Settlement

Causes:

1. Frost action (heaves)
2. Settlement of the base

Severity Levels: No degrees of severity are defined. Settlements and heaves should be noted only when they have a noticeable effect on the ride.

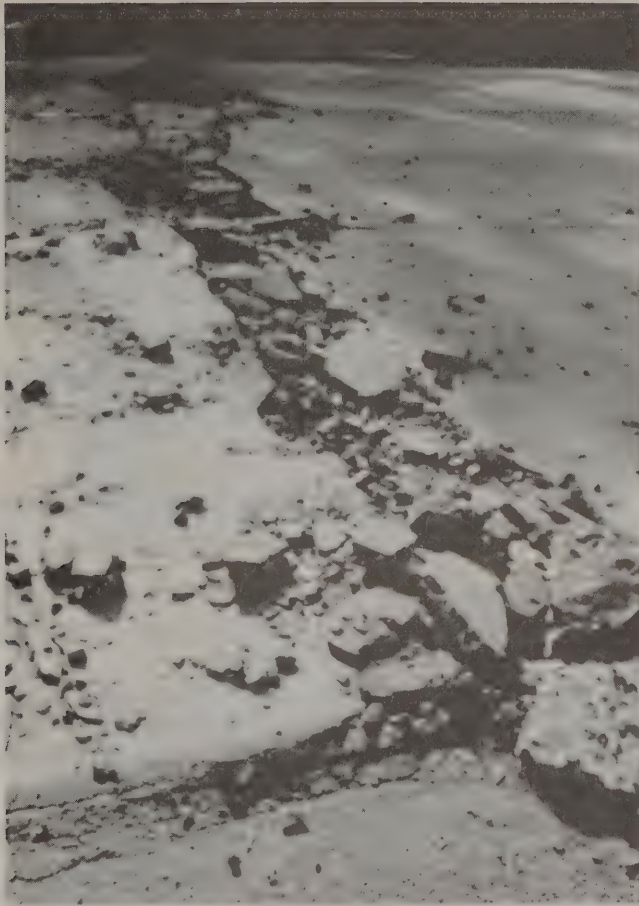
Figure B2 - Blowups

Blowup Showing
Shattered Concrete
Before Repair

A localized buckling or shattering of a slab generally occurring at a transverse joint or crack which may or may not have been patched with bituminous concrete. (Figure B2)

An infiltration of fines in unsealed transverse joints which acts as an incompressible medium. This incompressible medium will buildup due to the normal contraction which takes place in cold weather and the infiltration of abrasive sand and roadway dirt. The normal expansion during warmer weather will cause compressive stresses which are relieved when the pavement buckles or shatters.

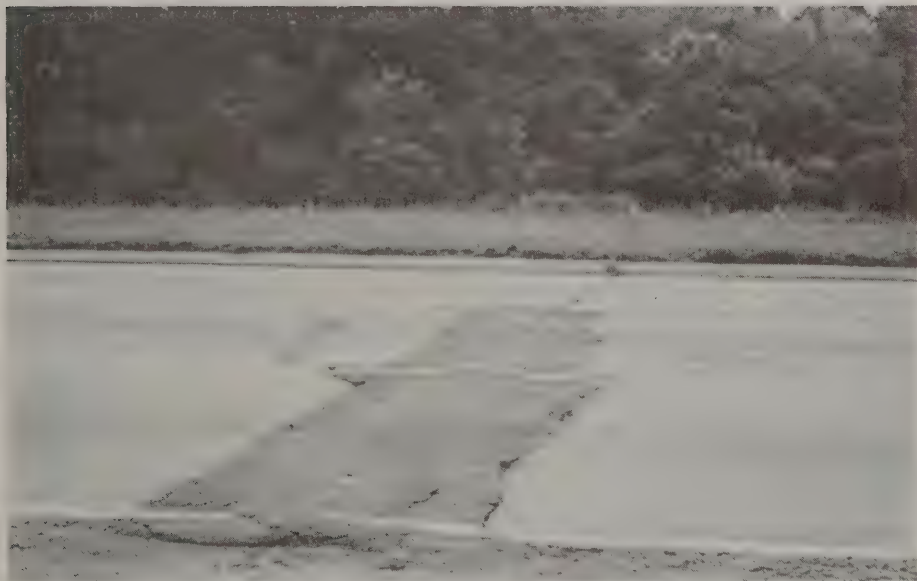
A partial width blowup occurs in one or some of the lanes of a multilane pavement. It does not extend across the full pavement width. Adjacent transverse joints will be seen to be misaligned as the slabs move toward the pressure relief caused by the blowup. A full width blowup occurs across the entire pavement width and does not cause transverse joint misalignment.

Partial Width Blowup That Occurred In The
Near Lanes Only And Has Been Repaired With
Asphalt Concrete

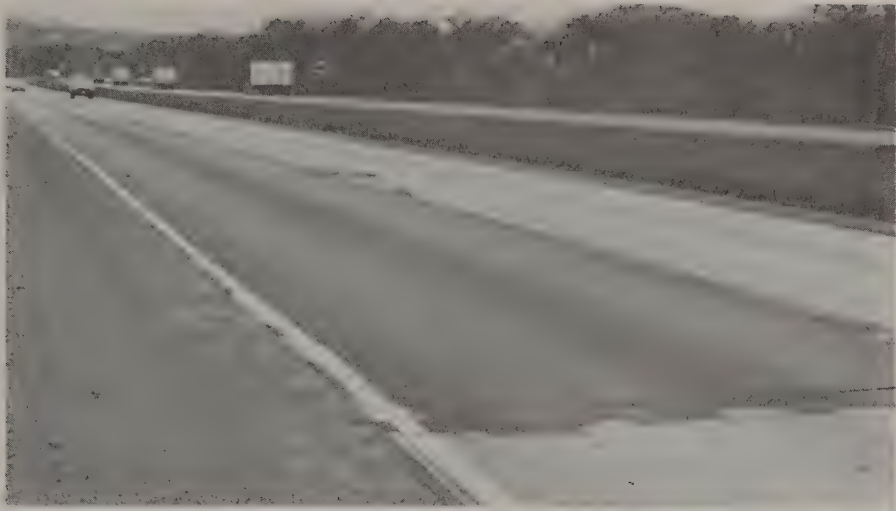
Figure B3 - Asphalt Concrete Overlay Patching

| | Good | Like new. Original condition of asphalt concrete overlay. |

Good

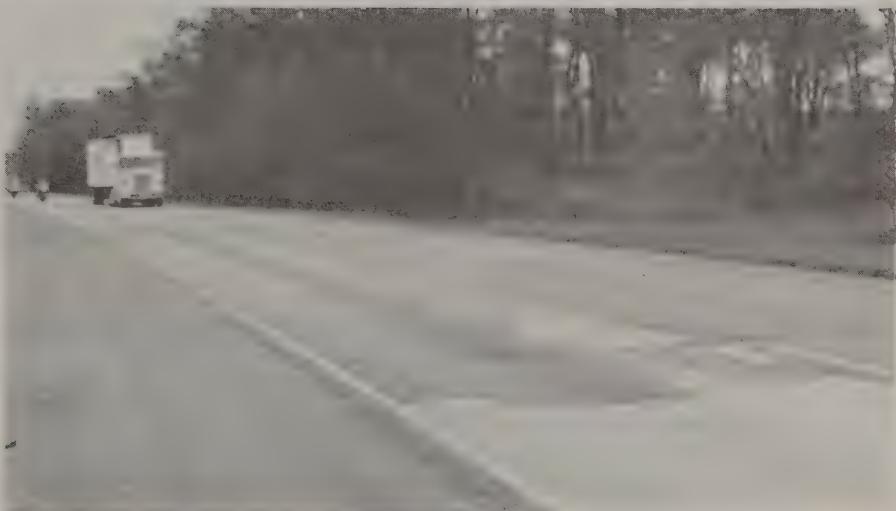
| | Fair | Underlying problem reflecting through. Cracks showing, potholes, spot patching by Maintenance forces. |

Fair

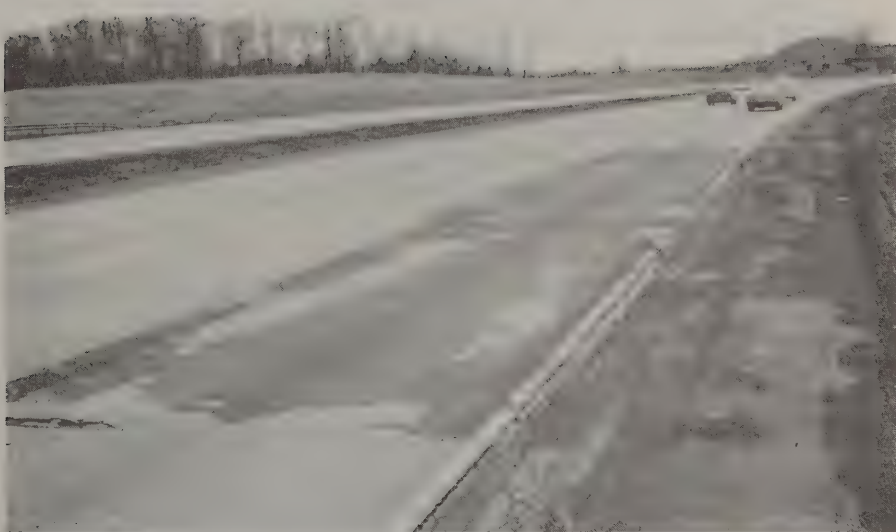
| | Poor | No longer serviceable, extensive deterioration has reflected through or the asphalt concrete has deteriorated to the extent where replacement is necessary. |

Poor

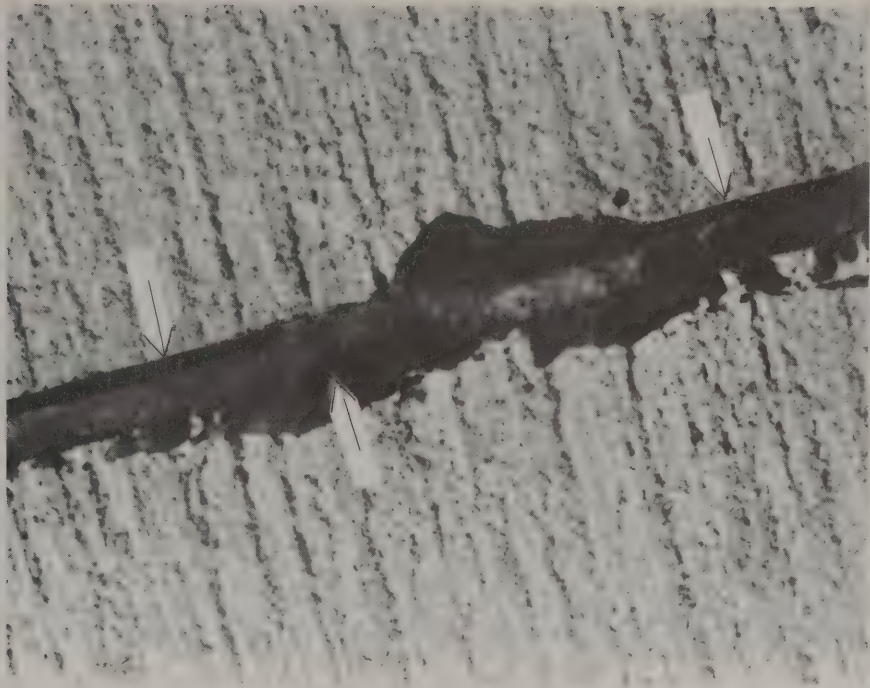
Figure B4 - Joint Sealer Failure

Liquid Sealer Adhesion Failure

Description: Liquid Sealers - Failure is characterized by loss of bond (adhesion) between the sealer and joint faces, internal tearing (cohesion) within the sealer itself and/or entrapment of incompressibles within the sealer matrix and/or loss of sealer from the joint. (Figure B4)

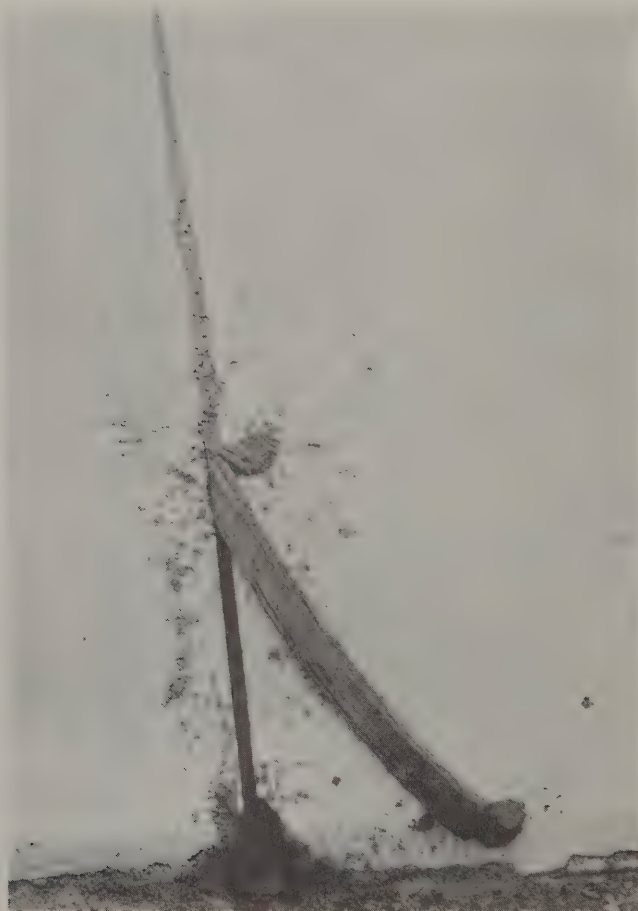
Preformed Neoprene Sealer
Compression Set Failure
Allowing The Infiltration
Of Incompressible Materials

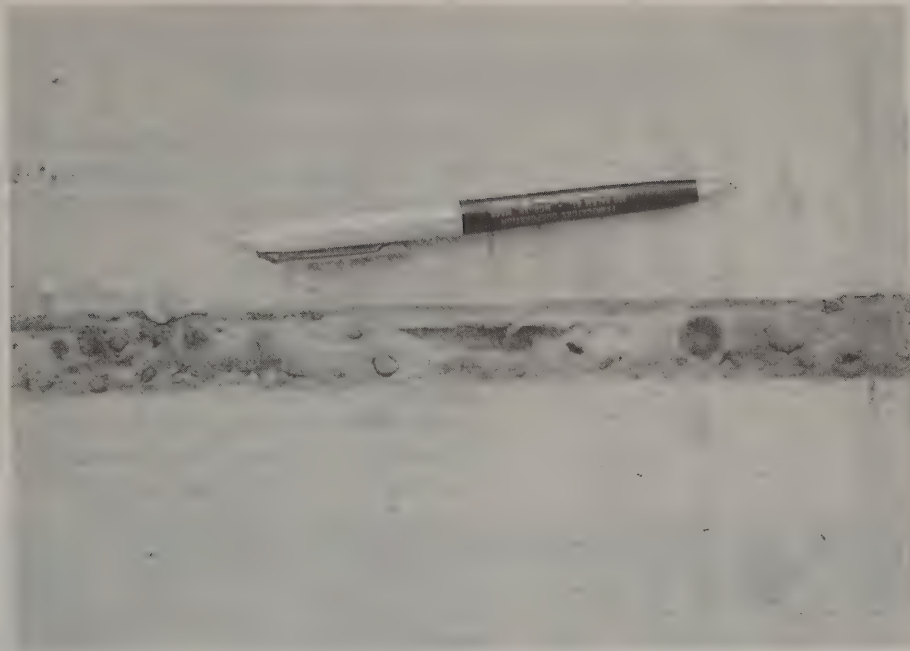
Incompressible Infiltration In A Liquid Sealer

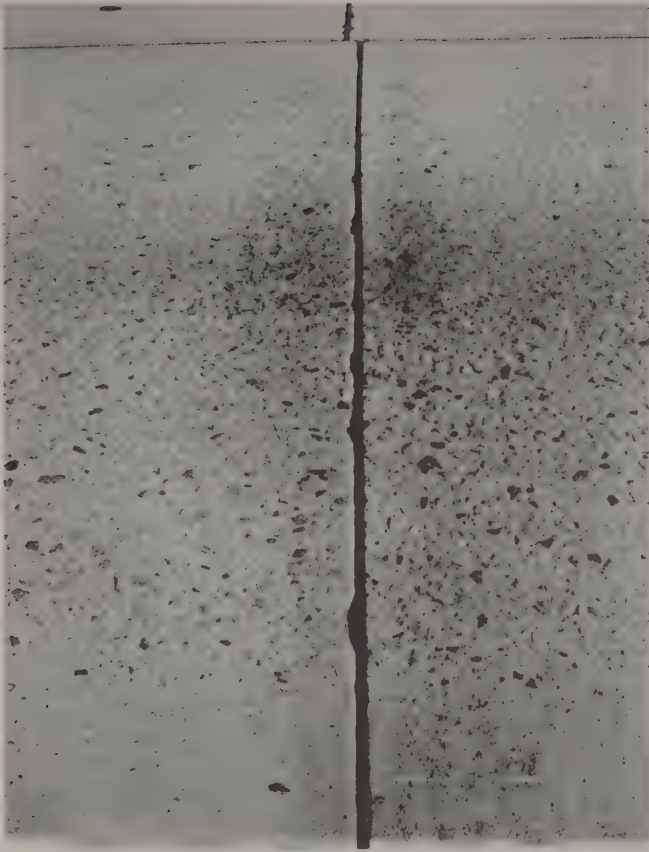
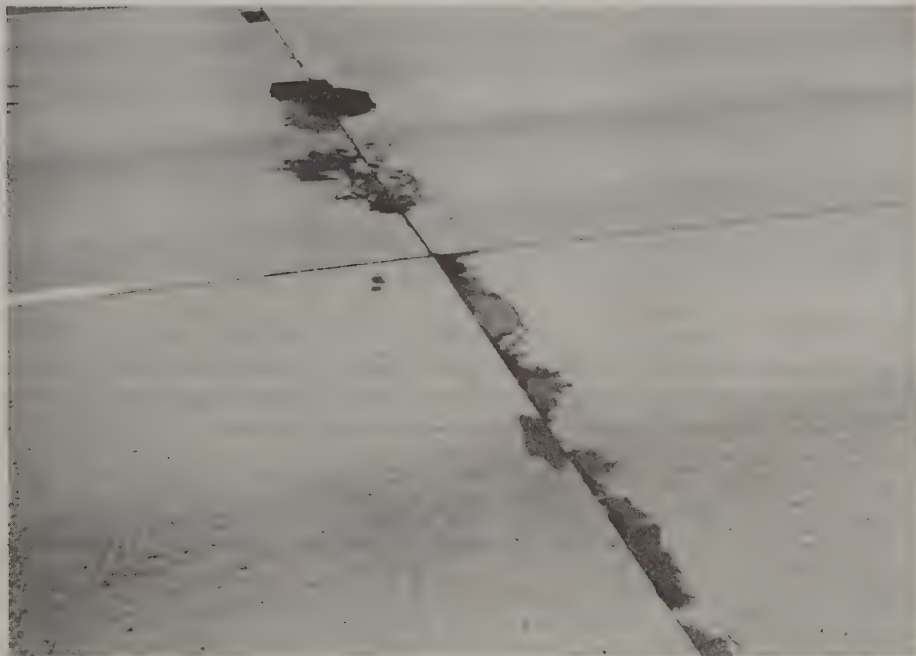
Low

Medium

High

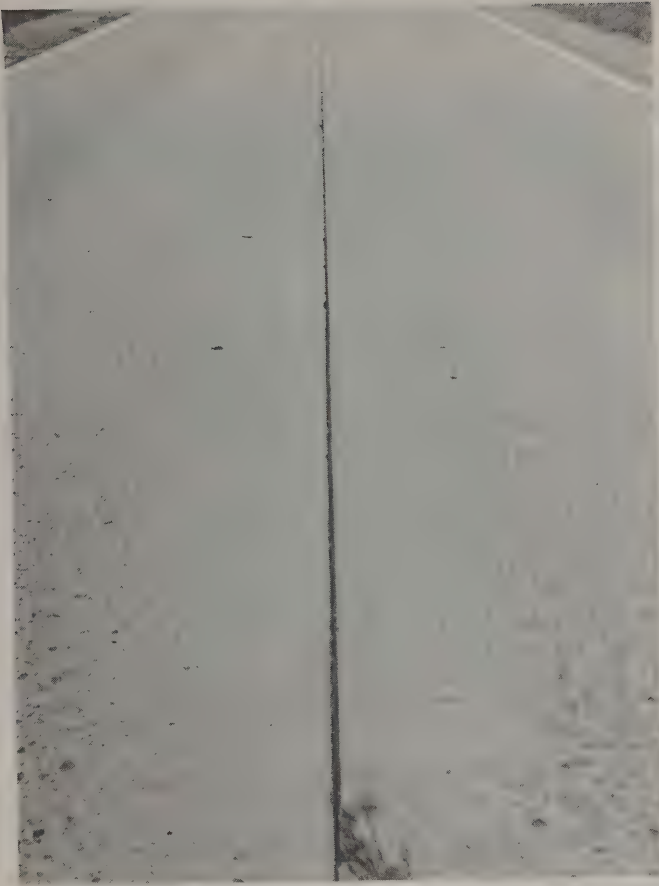
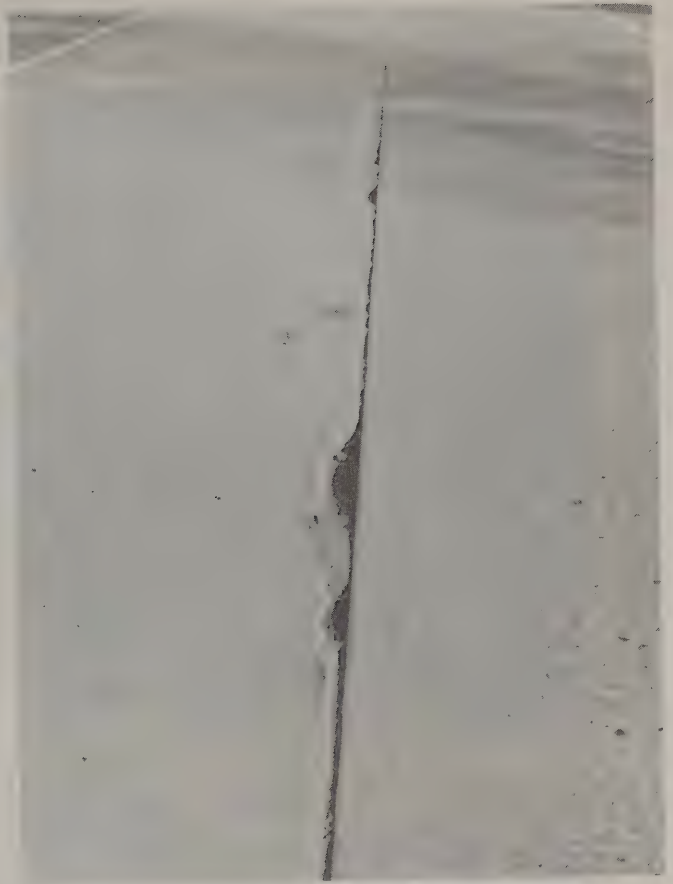
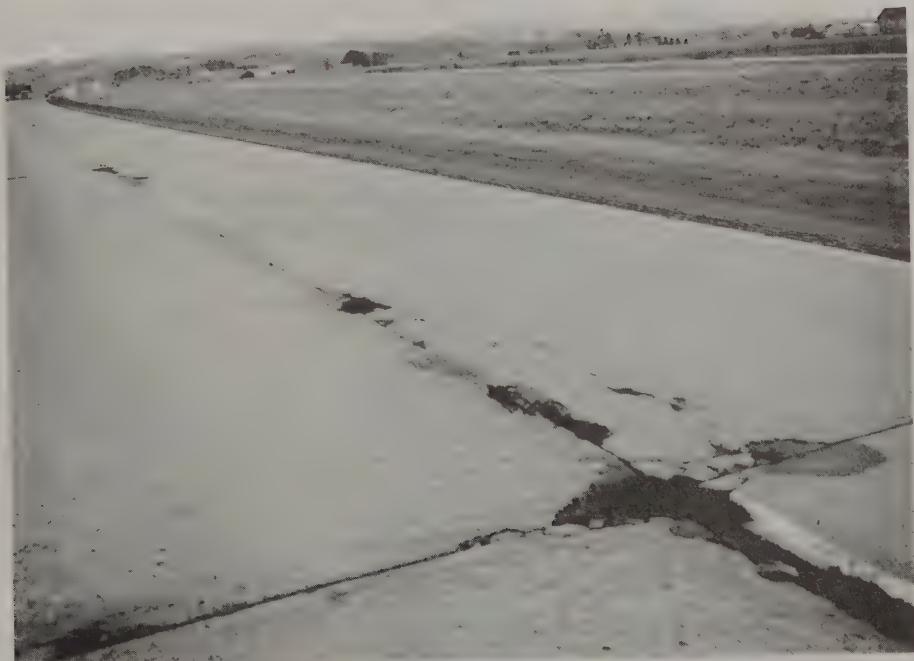
Figure B9 - Longitudinal Joint Distress

Low

Medium

High

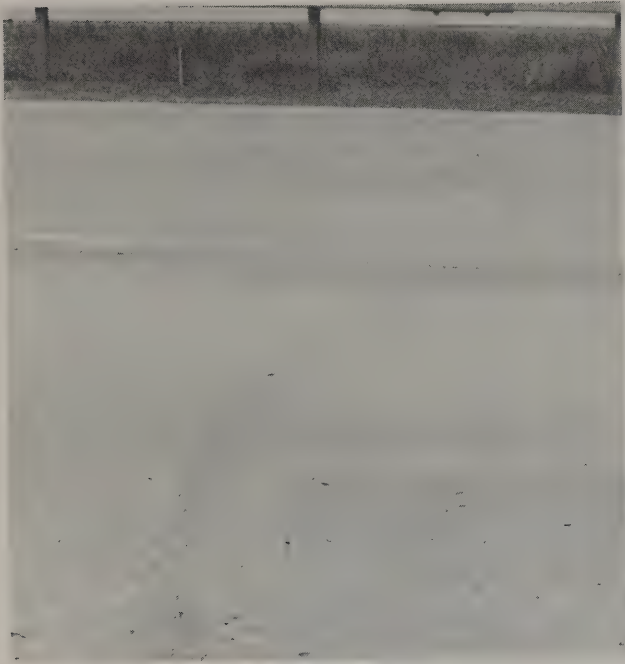
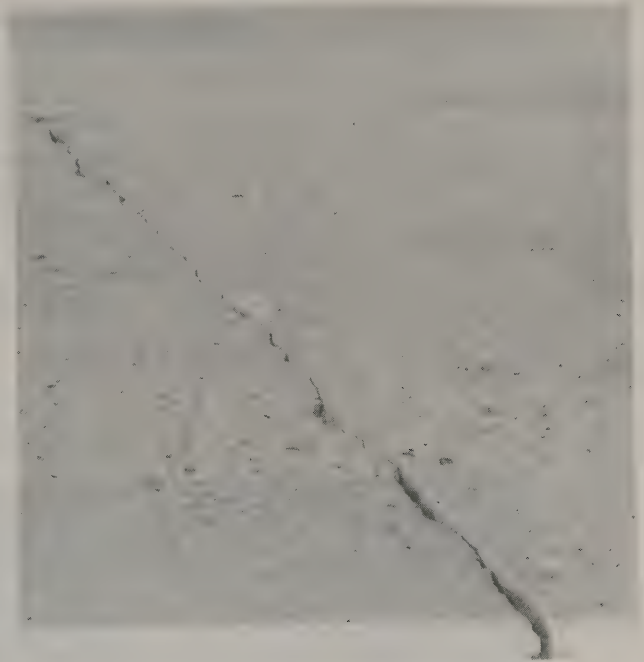
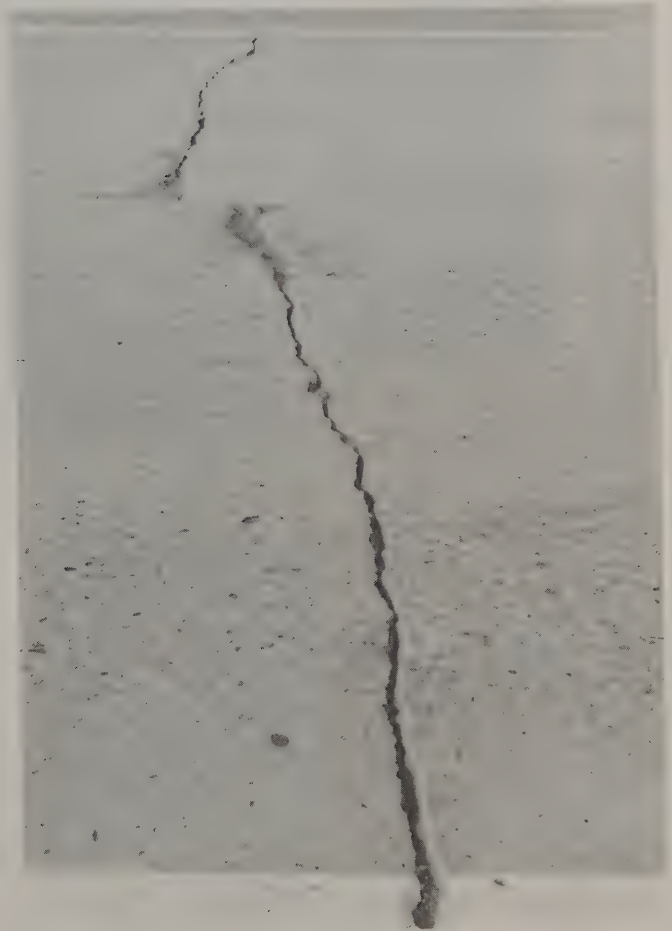
Figure B10 - Slab Cracking

Low

Medium

High

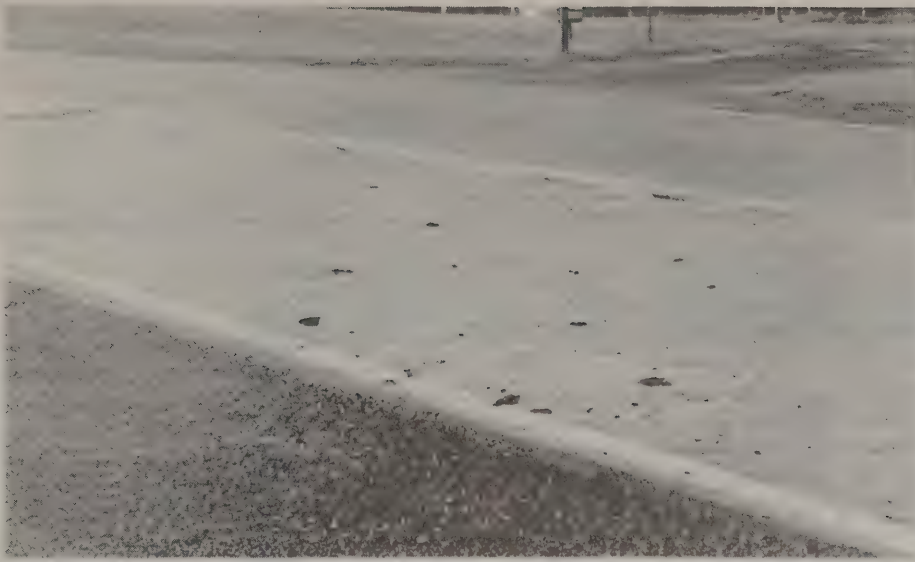
Figure B12 - Scaling Non-Joint Spalling

Low Spalling
Popouts

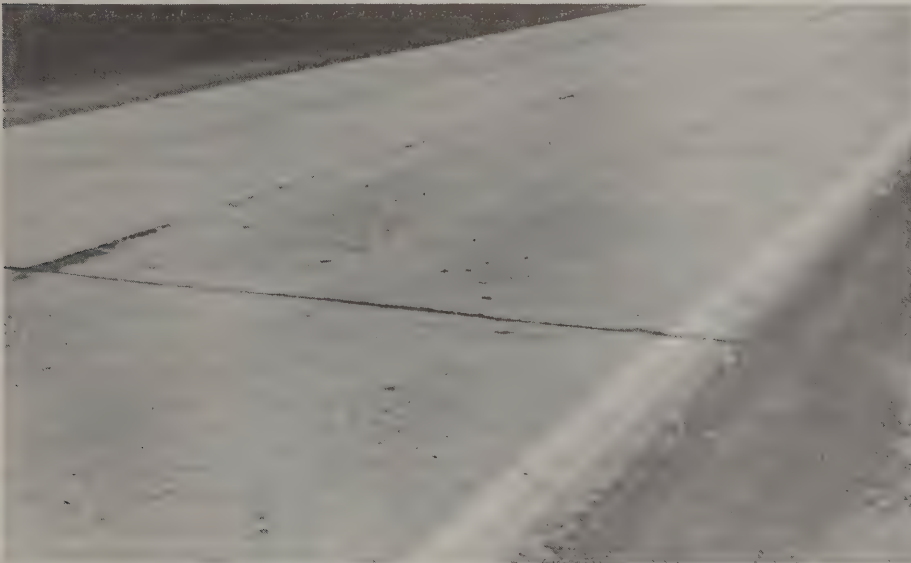
Medium Scaling
Showing Deterioration
Of Mortar

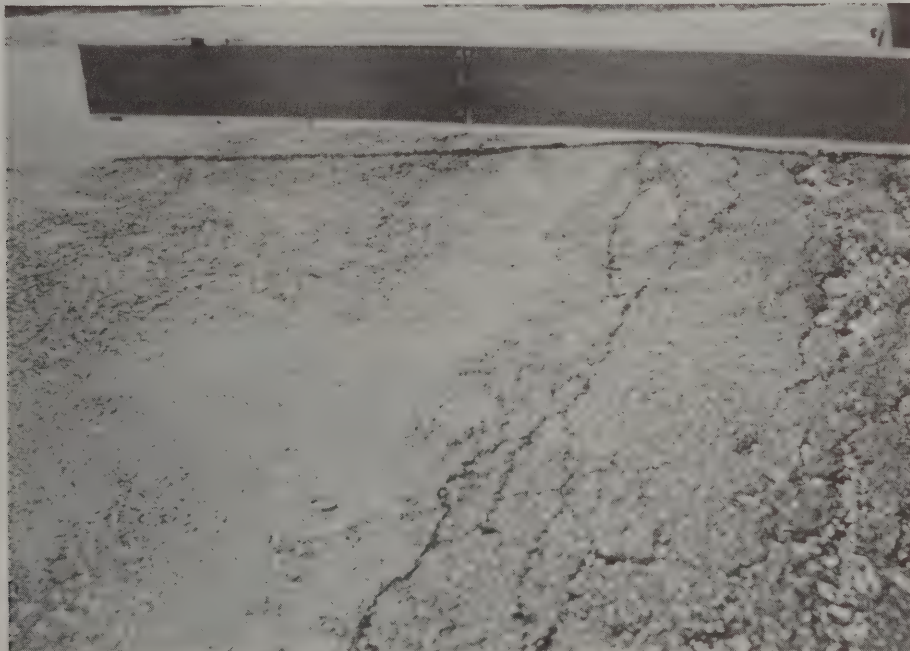
Figure C2 - Settlements And Heaves

Severe Heave

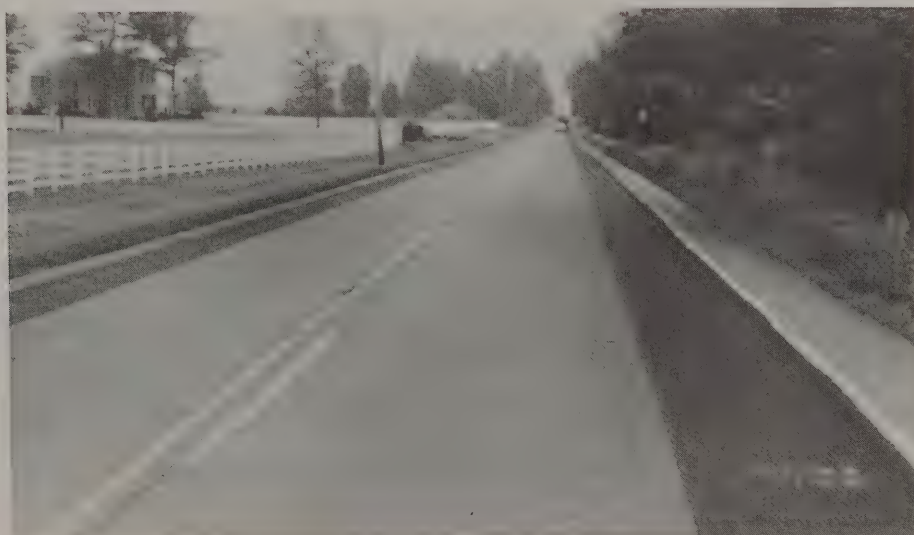
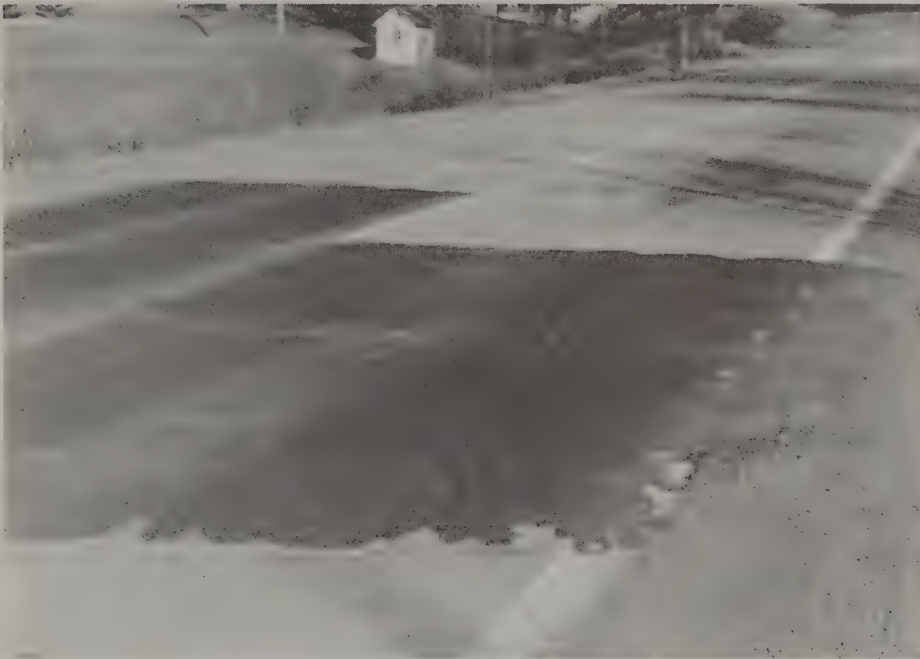
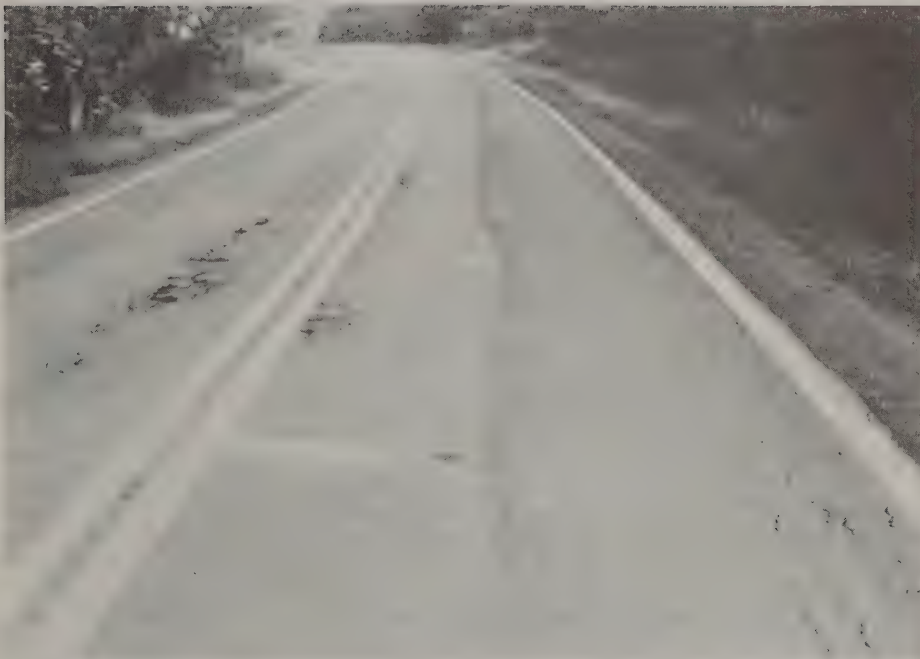
Figure C3 - Asphalt Concrete Overlay Or Spray Patch

Good

Fair

Poor

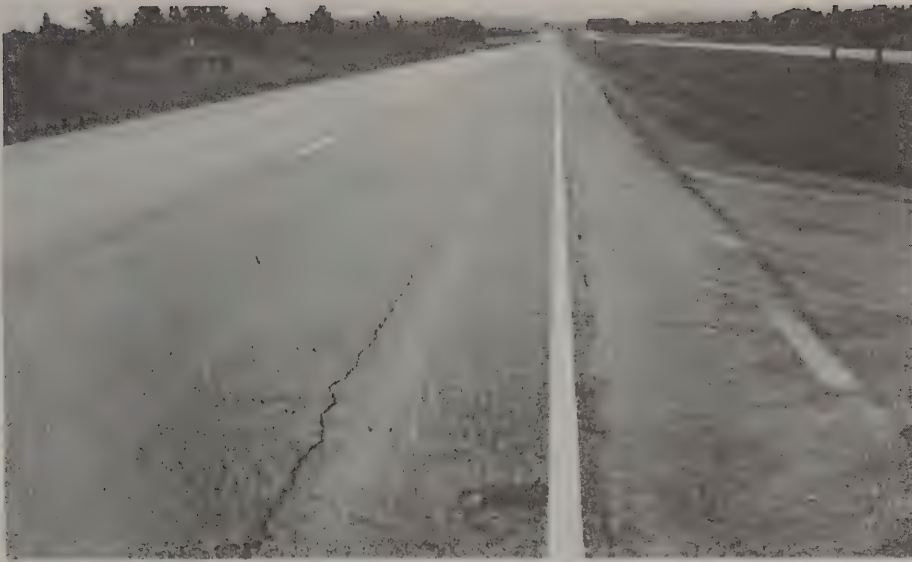
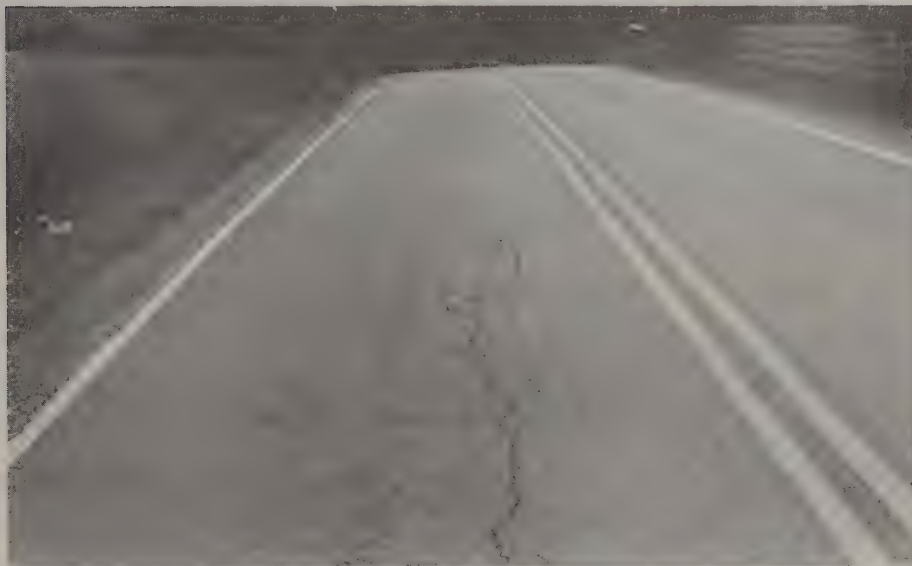
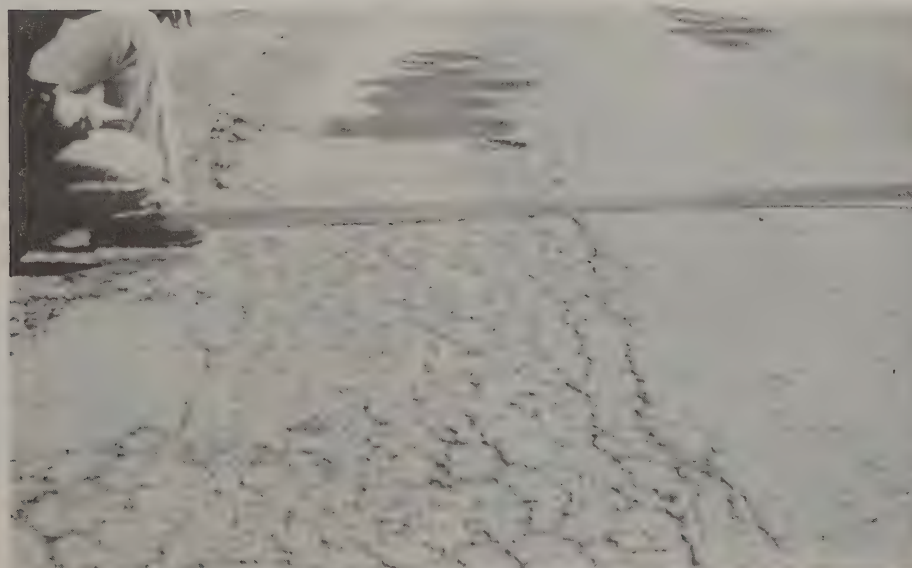
Figure C4 - Wheelpath Cracking

Low

Medium

High

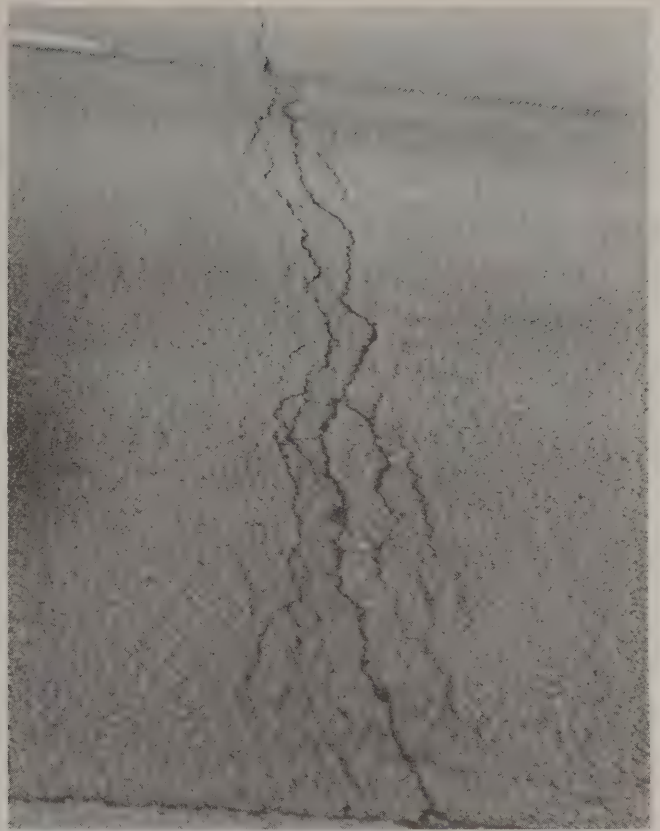
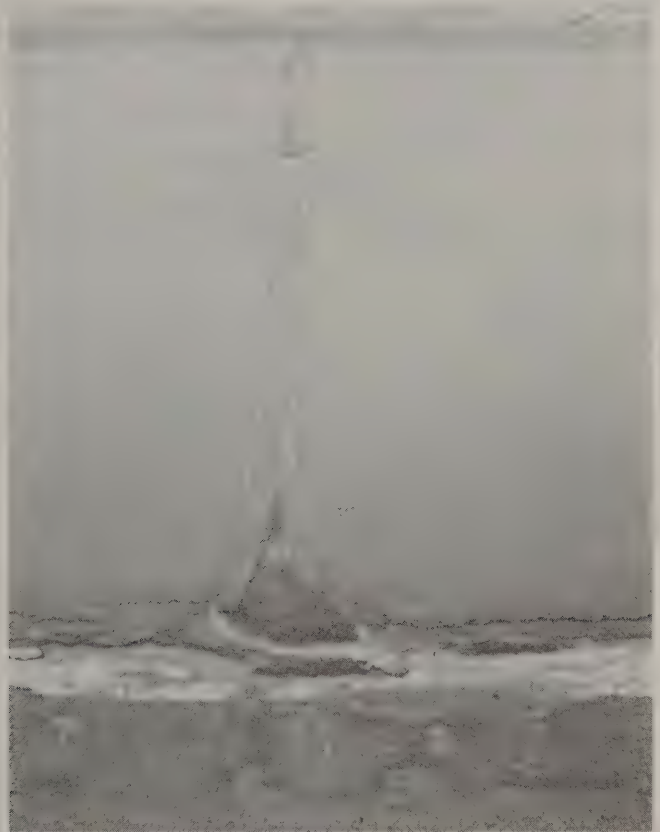
Figure C5 - Full Width Transverse Cracking

Low

High

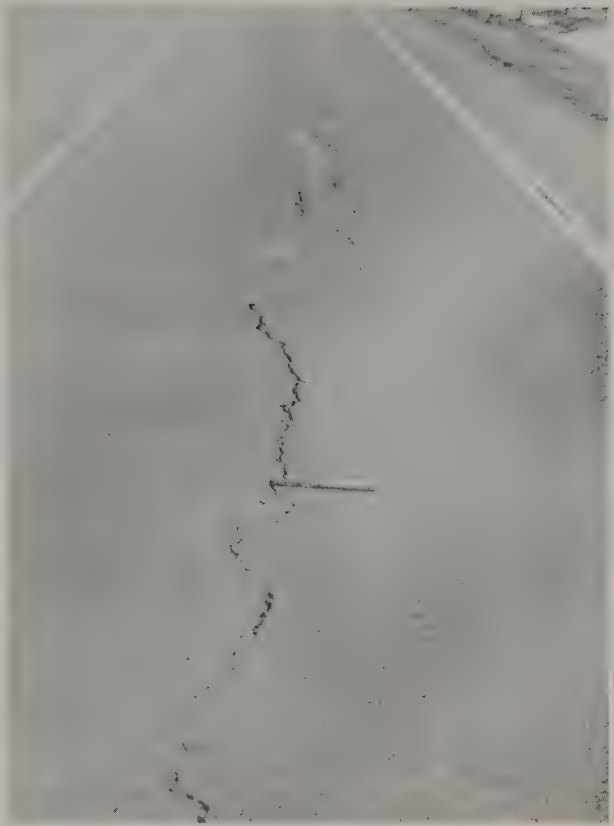
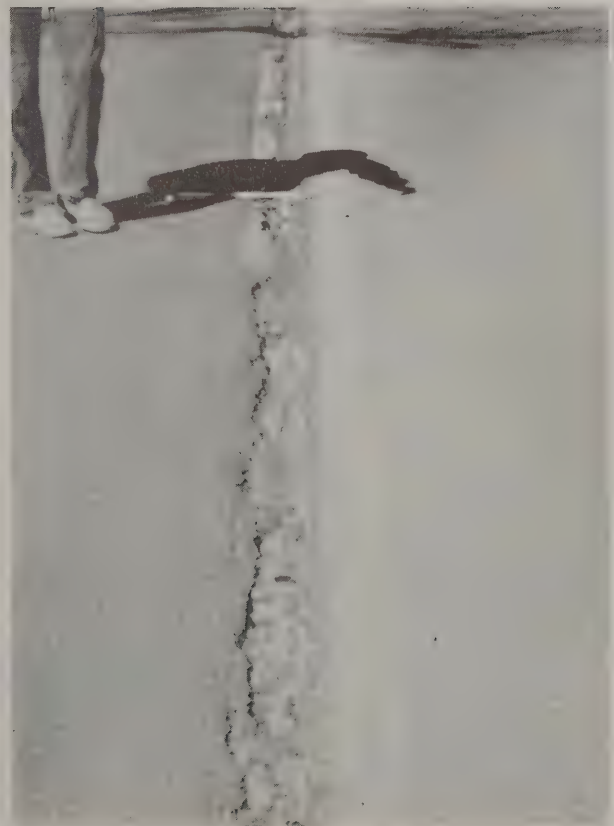
Figure C6 - Longitudinal Cracking

Low

Medium

High

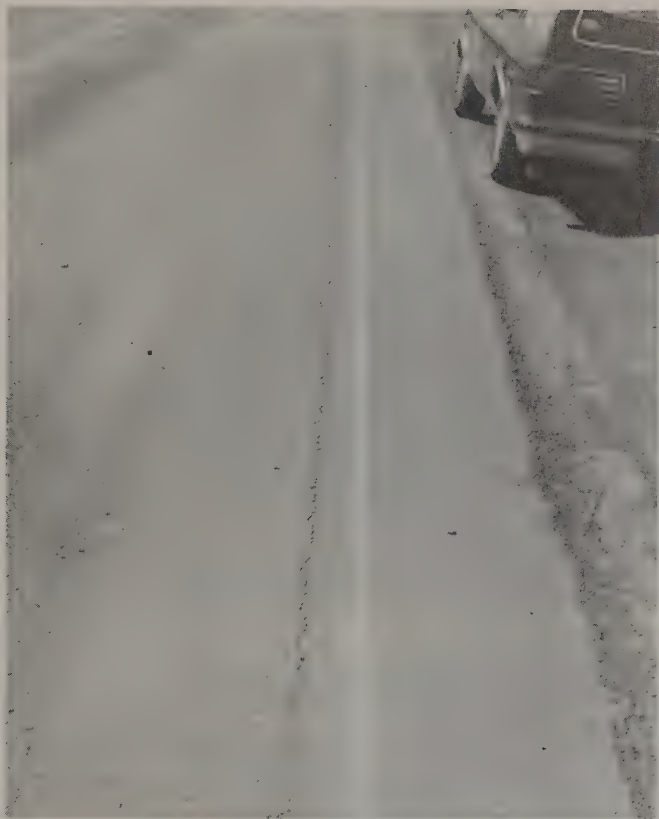
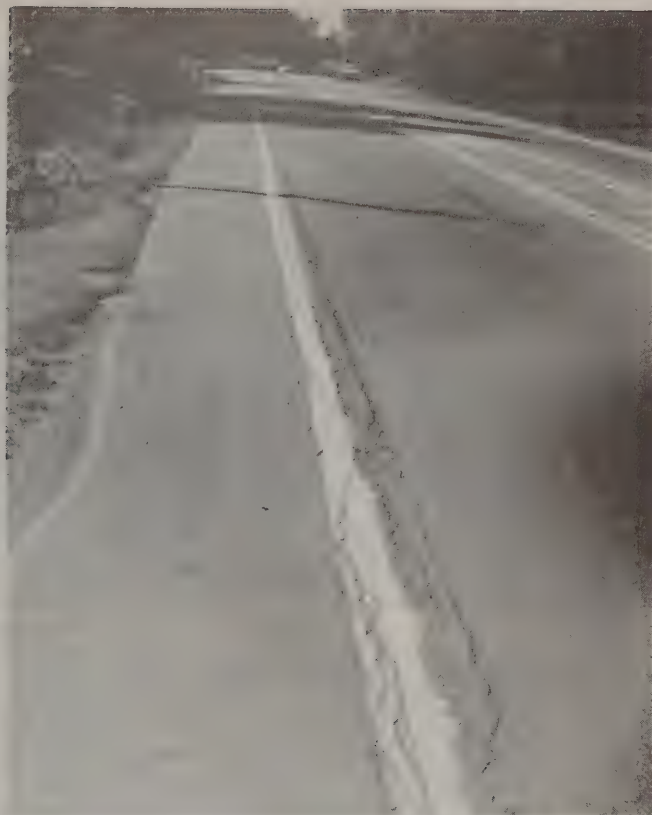
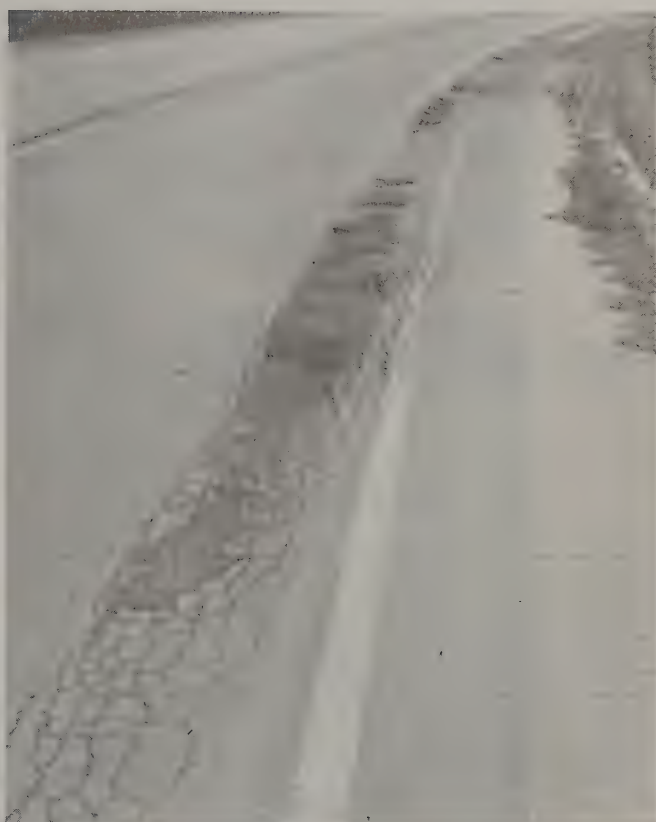
Figure C7 - Edge Cracking

Low

Medium

High

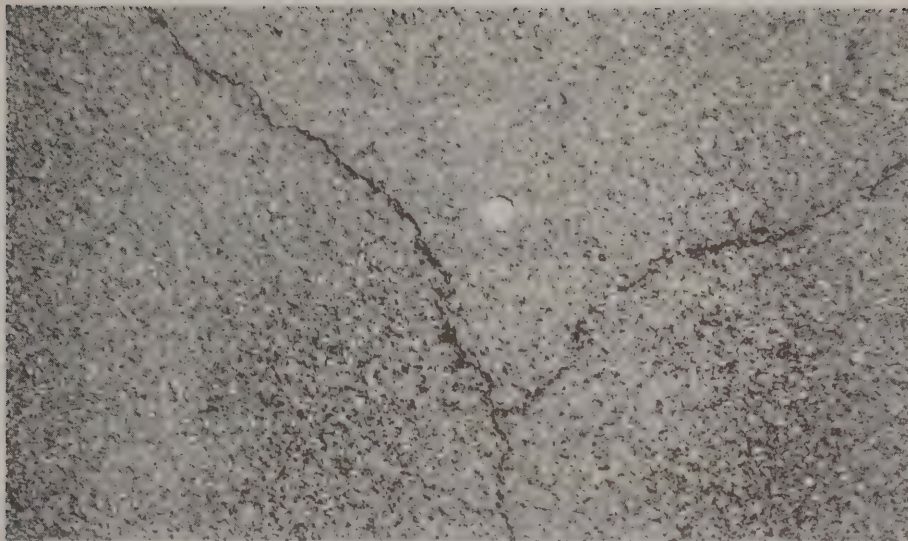
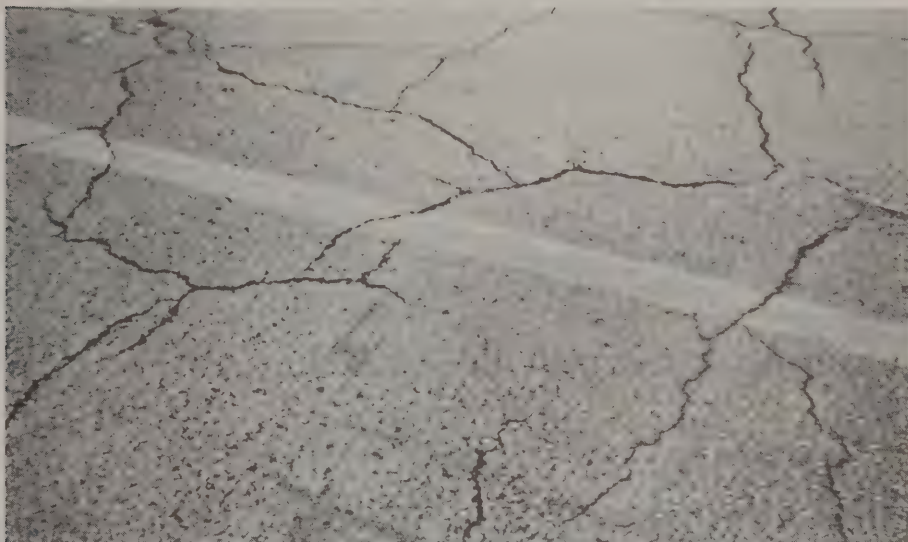
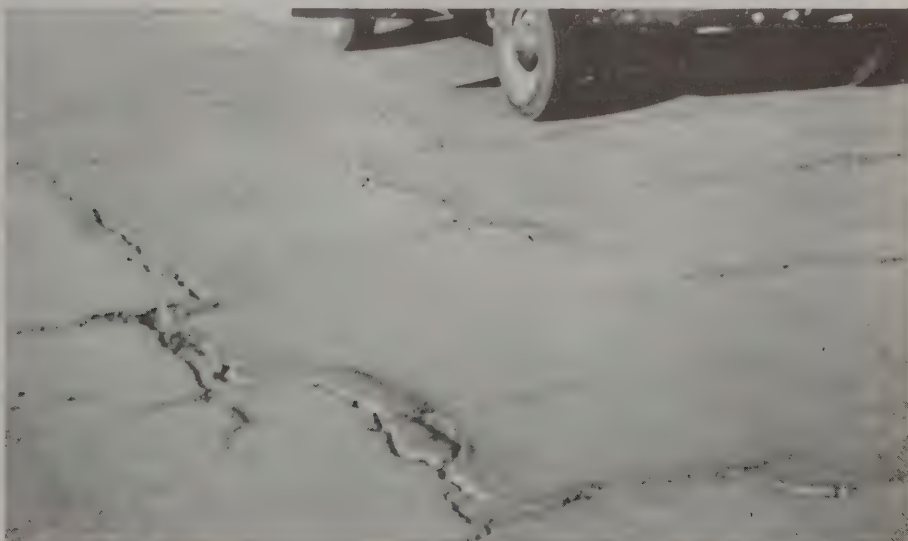
Figure C8 - Cracking (Other)

Low

Medium

High

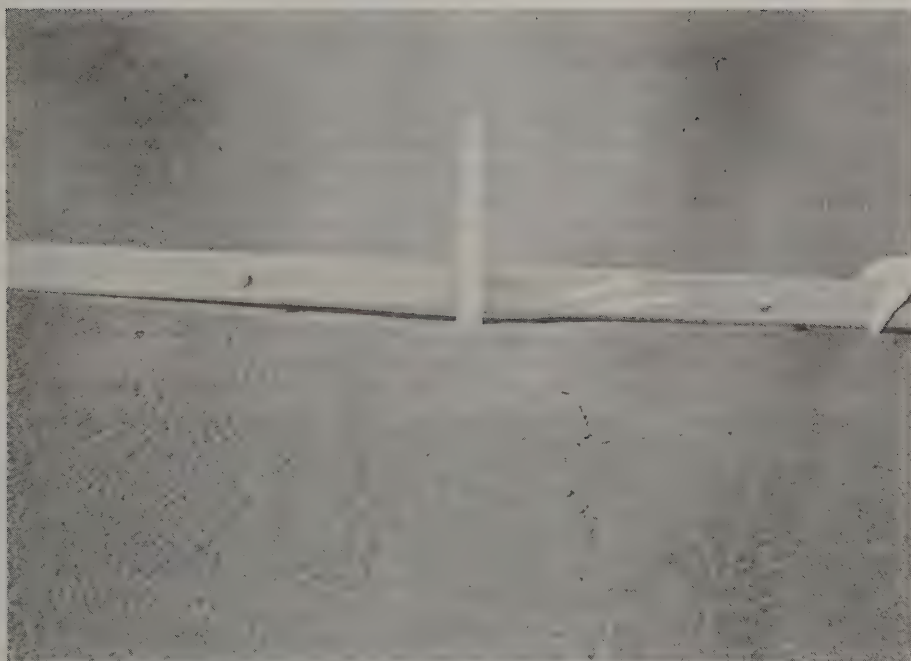
Figure C11 - Wheelpath Rutting

Medium

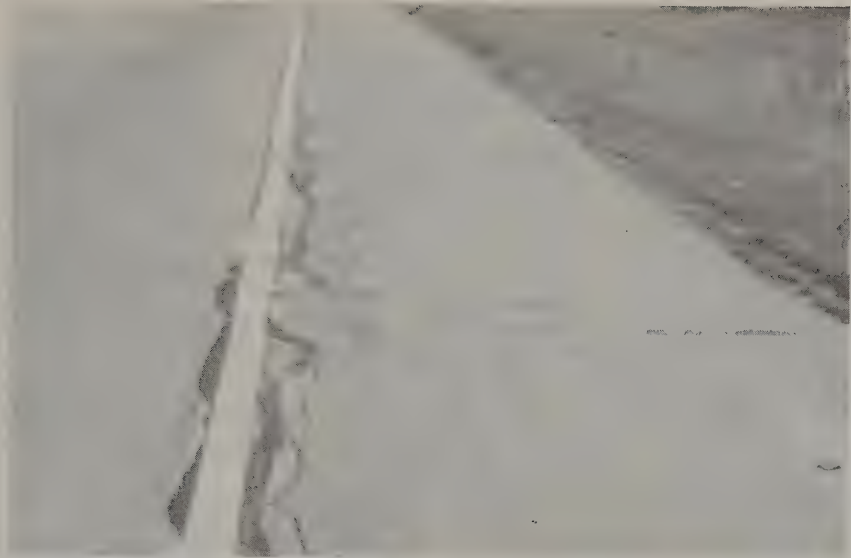
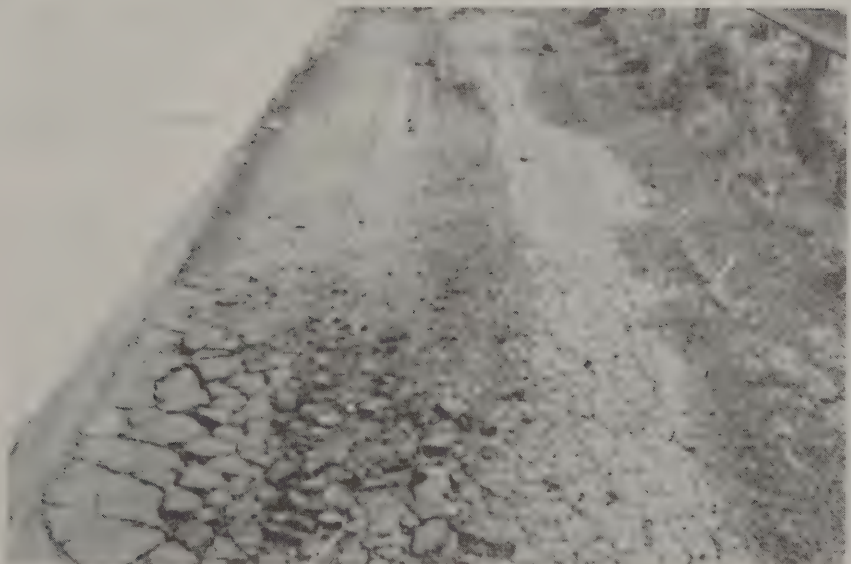
Figure D1 - Shoulder Deterioration

Low

Medium

High
